**NASA TM X-1773**

**FLIGHT-TEST RESULTS FROM  
SUPERSONIC DEPLOYMENT OF  
AN 18-FOOT-DIAMETER (5.49-METER)  
TOWED BALLUTE DECELERATOR**

*by Robert J. Maybue and Clinton V. Eckstrom*

*Langley Research Center*

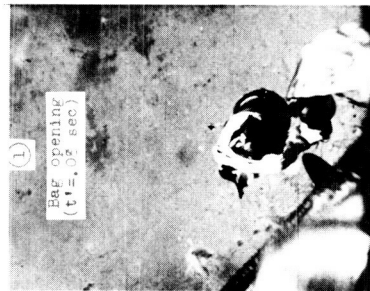
Figure 7.- Photographs of deployment and inflation with tensiometer forces.

Significant events that occurred during deployment and inflation of the test ballute are summarized in the photographs of figure 7. Time histories of the payload accelerations and tensiometer forces measured after mortar firing are shown in figures 8 and 9, respectively.

The photographs, taken with the rearward-facing camera, and corresponding tensiometer forces (fig. 7) indicated normal deployment, extraction, and filling of the test ballute up to about 1 second after mortar firing. Then ballute growth appeared to stop and an average plateau drag force of 1500 pounds (6.7 kN) was maintained during the time interval between about 1 and 2 seconds. The maximum force anticipated at full inflation was of the order of 3800 pounds (17 kN). A sudden drop in the drag force then occurred, followed by a slow decay to approximately 300 pounds (1.3 kN) for the duration of the flight.
